Date: May 15, 2008
To: Jim Keim, Village of Antioch and Director of Physical Services
From: Bob Davies, SEC Group, Inc.
cc: Tim Hartnett, SEC Group, Inc.
Re: Fire Station Smoke Tower
SEC Job No: ANTI-080197.01-MU06

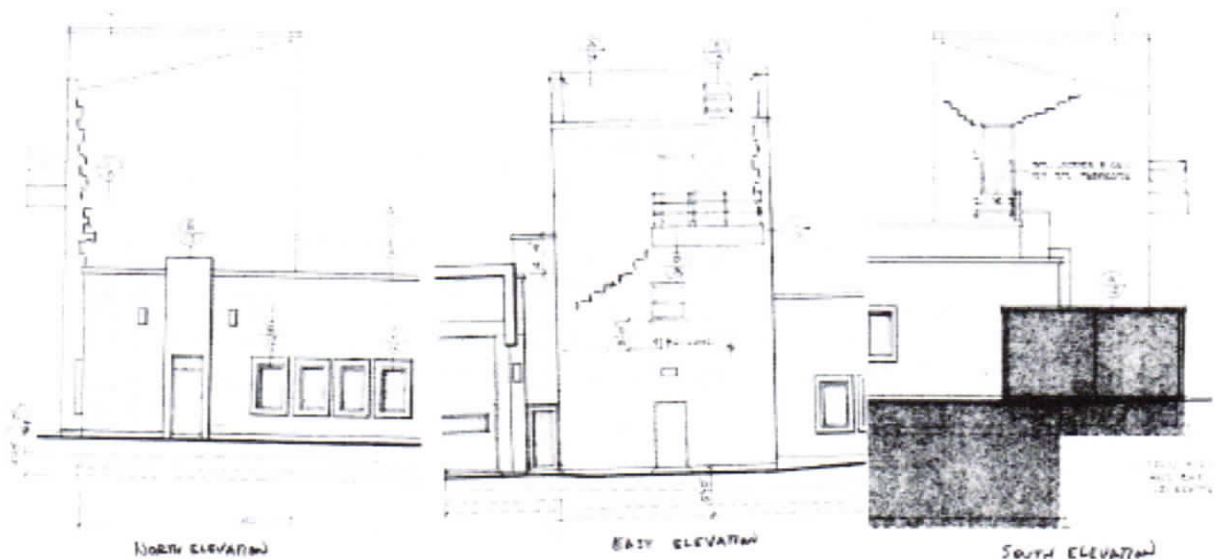
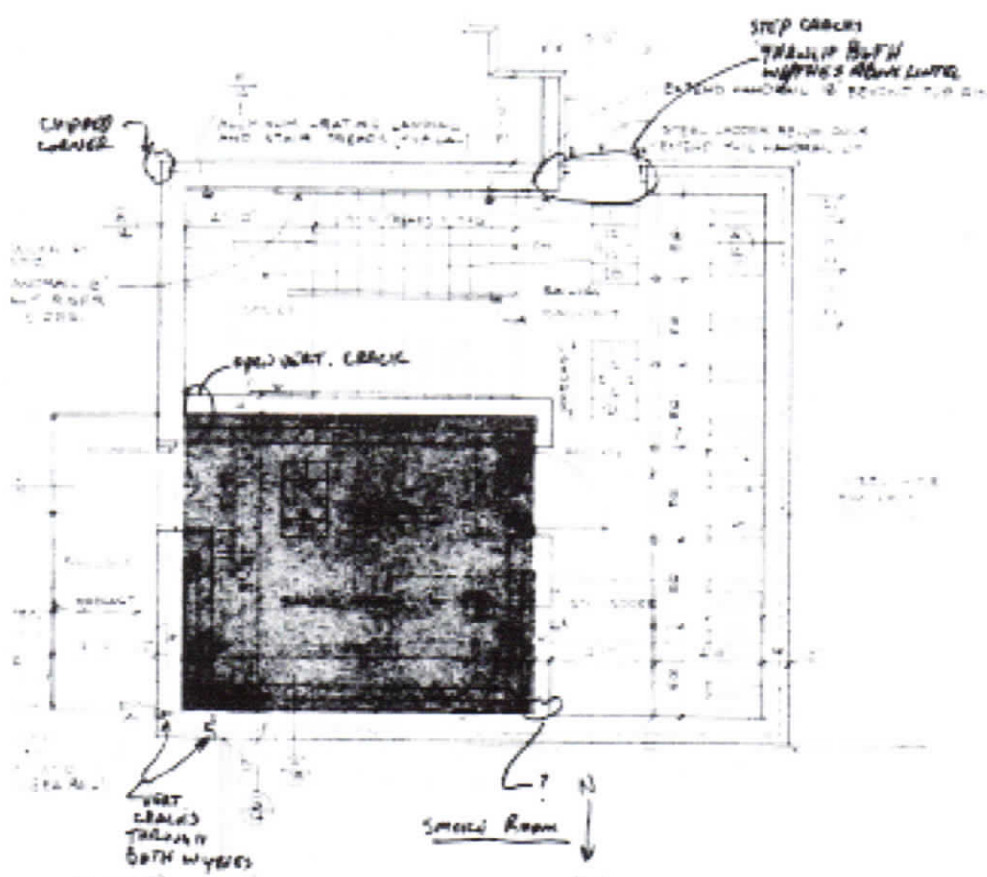
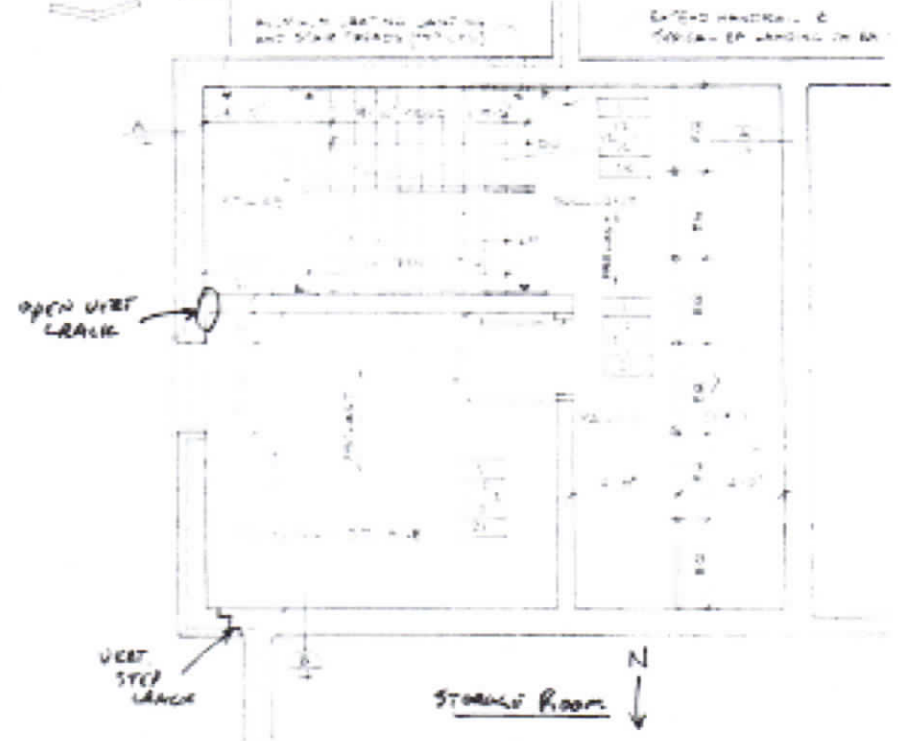
Generally, vertical step cracking was noted in the north and east walls around the northeast corner of the tower. The cracks ranged up to approximately 1/8" and appear to be relatively recent. Some of the cracks show through the outer wythe of brick masonry. An open vertical crack between the east exterior wall and the interior concrete masonry partition separating the stair tower from the rest of the smoke tower was also noted the crack is approximately 1/8" and runs nearly the full height of the tower. Step cracking was noted in the east wall at the smoke room floor elevation extending from the balcony to the southeast corner. On the south wall, the masonry above the smoke room level roof access door lintel is cracked up to the parapet and has moved out of plane. The areas in question are summarized on the attached sketches.

indicate the non-bearing edges of the plank are locked into the masonry which does not allow the precast concrete to camber upward as it would be expected to do over time. These conditions are not typical for a masonry building and may have caused confusion interpreting the architect's intent resulting in discontinuities or an absence of reinforcement in the walls. The size of the cracks observed indicates whatever reinforcement steel is present is not controlling crack size.

We recommend a masonry contractor be brought in to check the stability of the parapets and verify bed joint reinforcement connects the partition to the exterior wall. If this reinforcement is in place, the cracking should be manageable with tuckpointing and caulking. If it is not in place, reinforcement and/or reconstruction may be appropriate in some parts of the smoke tower. If the parapets are not stable the Village should take immediate action.
